Test report TL13-60013/2

EPIL TEST REPORT

Equipment Under Test: *Transmitter Enclosure*

Tested According to: IEC 60529 2013 COR1:2019

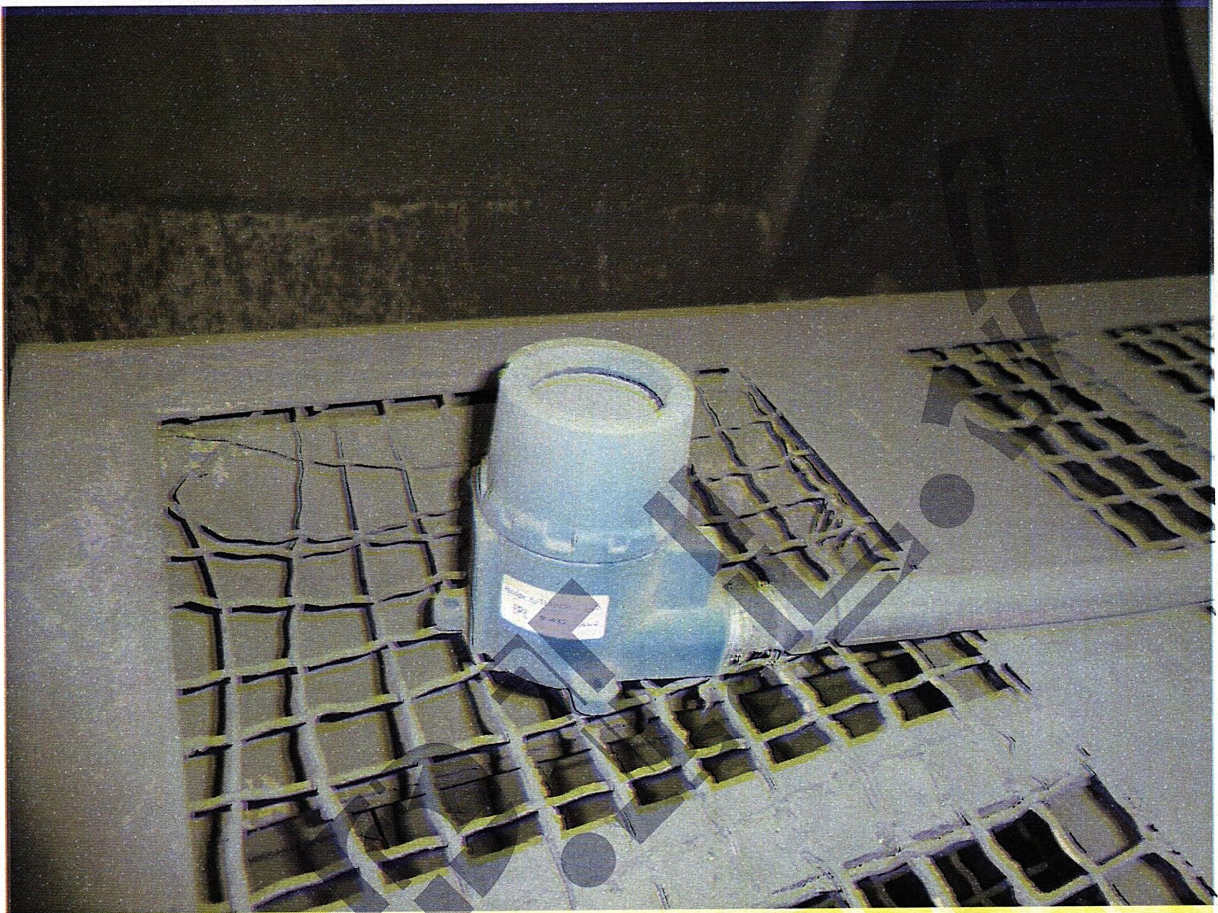
Figure 2: EUT after IP6X

The protection is satisfactory if no deposit of dust is observed inside the enclosure at the end of the test.

The test was done according to IEC 60529 and it passed the test
